Mercury Flooring

The Hidden Dangers and Potential Solutions

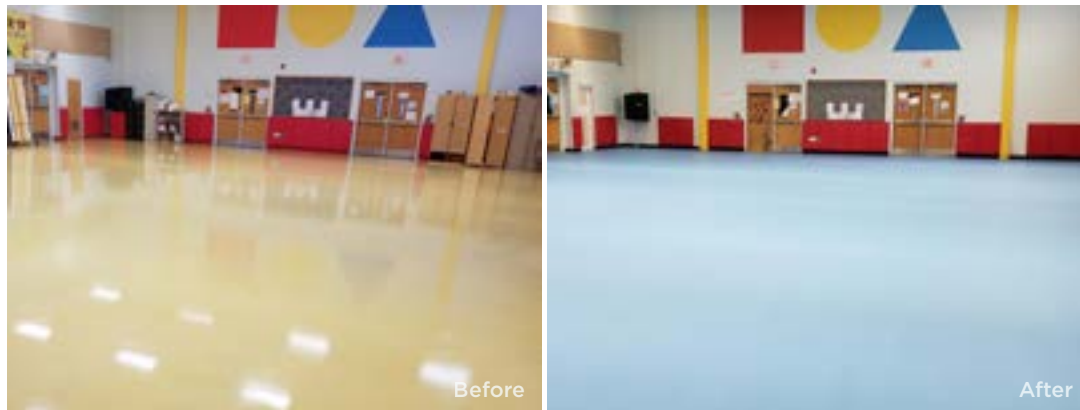
VHB worked with the New Jersey School Development Authority (NJSDA) to evaluate the potential presence of mercury-containing floors in local school district buildings. Once suspect flooring was identified, VHB's Certified Industrial Hygienist (CIH) collected samples for analysis, performed a Risk Assessment, and found mercury vapor in the indoor air at concentrations exceeding the New Jersey Department of Health (NJDOH) threshold. VHB coordinated with the school district and NJSDA in the abatement design process, performed oversight of the abatement process, and performed final clearance sampling to verify that the mercury hazard had been effectively mitigated and replaced.

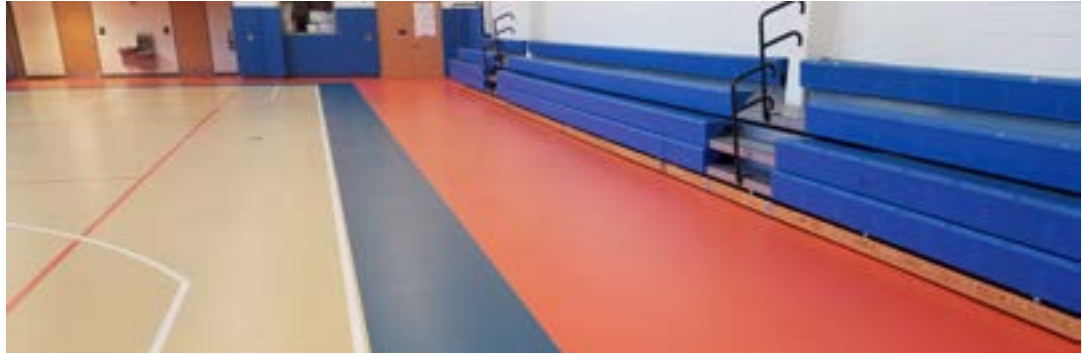
Resilient, multi-use flooring can now be installed without the use of PMA as a catalyst. VHB led the removal and disposal of PMA flooring from this school gym and led the abatement and replacement with safe materials.

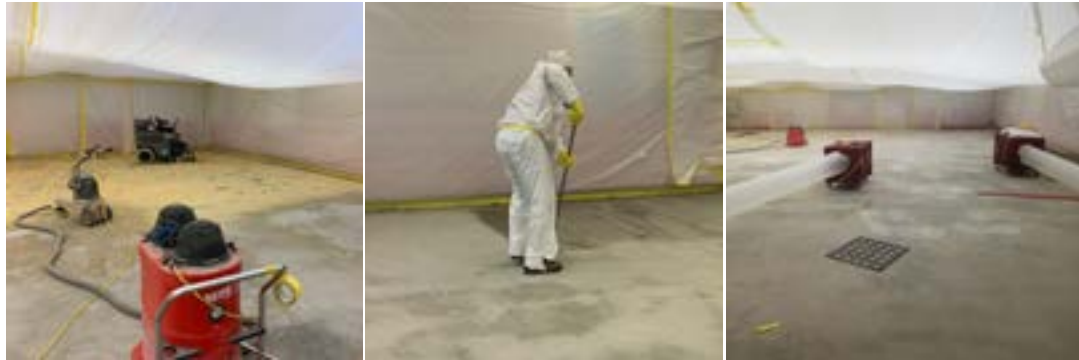
PMA flooring is removed by isolating the work area, monitoring air vapor, dust and debris control, and providing personal protection equipment for workers. Negative-pressure containment and decontamination chambers for personnel, equipment, and waste are utilized to prevent mitigation of mercury vapor or contaminated dust out of the work area.

If the results exceed established thresholds, the CIH will assist in determining the appropriate solution. Possible corrective actions may include vapor mitigation or abatement of the flooring. The only way to permanently eliminate the risk of mercury hazard is to abate the floor, which involves decontamination processes during abatement and the replacement of the floor with a new surface.
